July 14, 2020

HIOKI E.E. CORPORATION

Product Recall and Repair: CONNECTION CORD L9197

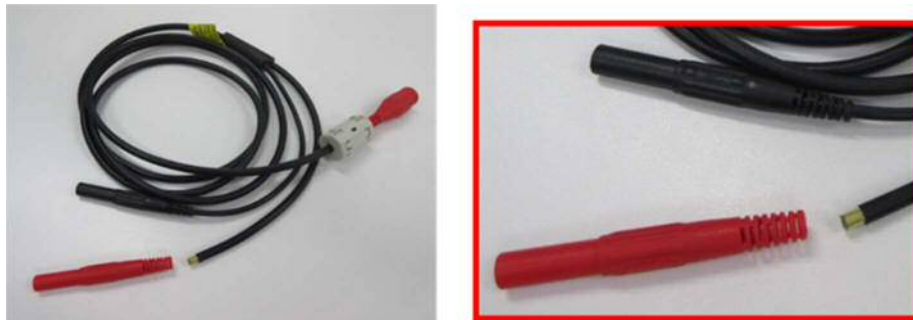
Figure 1: Brake and come off condition

- 1. The red banana terminal of the coaxial cable may brake and come off after being used only for about 10 times (Figure 1). Two cases have been reported out of 2,231 units shipped from HIOKI, as of May 20, 2020,.

Due to a cable processing failure, the insulator in the coaxial cable was notched, so that the bending resistance of the coaxial cable became extremely weak. Then, the wire gets cut by repeating bending.

- 1. The affected products are repaired by adding the adhesive heat shrink tube to the red banana plug. The appearance is changed as in the Figure 5.

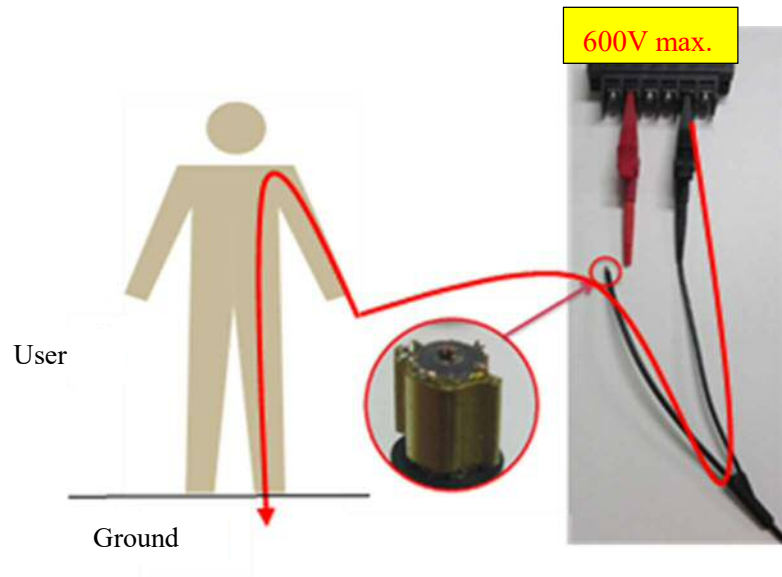
Figure 2: Exposed metal fitting

- 2. There is a risk of getting electric shock when a customer touches to the exposed metal fitting of the cut off coaxial cable while the black crocodile clip is connected to the live circuit (Figure 2).

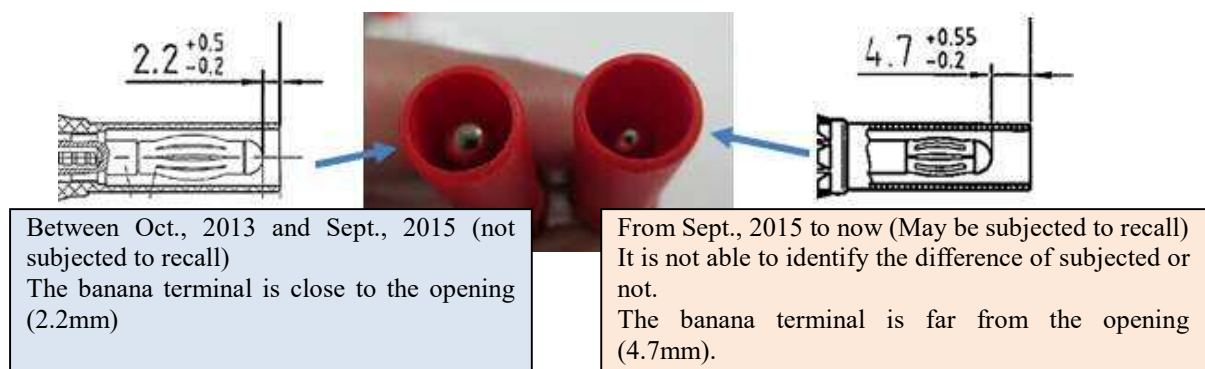
Figure 3: Different banana terminal position

The different banana terminal position in Figure 3 may help to understand the approximate production period.

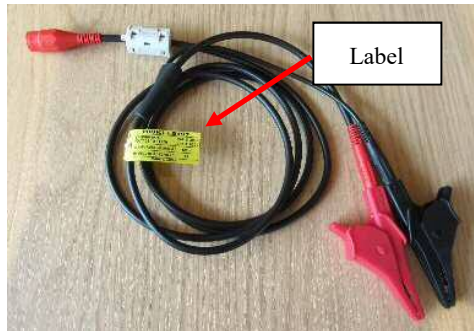
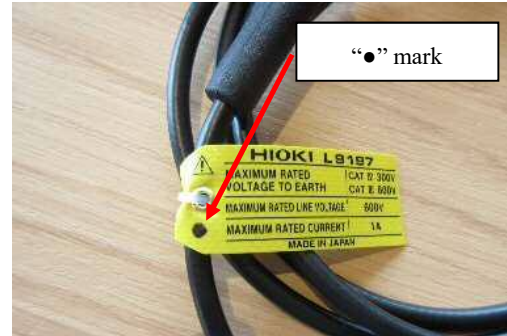
Figure 4: Identification of the fixed products

The fixed product has “●” mark on the product label (Figure 4).

L9197 appearance

L9197 shipped on or after May 19, 2020

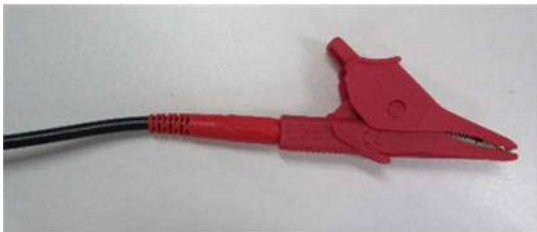
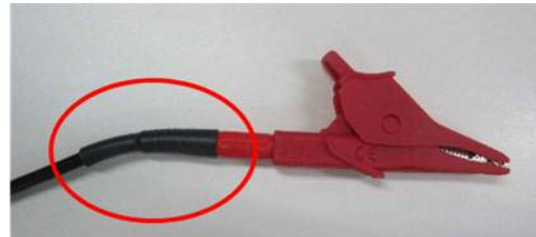
Figure 5: Appearance before and after the corrective repair

Before the repair (no heat shrink tube)

After the repair with heat shrink tube
