## Partial Discharge Testing of Motor Stators Using an Impulse Tester and Oscilloscope

# Application Note

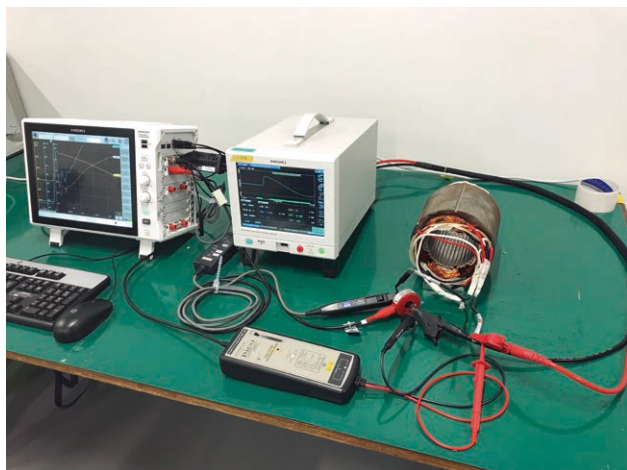
An impulse tester is connected between the coils of a stator that is connected to the neutral point (Figs. 4 and 5). Two CT probes are attached to the ground side. CT1 measures from DC to 120 MHz, while CT2 measures from 4.8 kHz to 400 MHz. The current waveforms from these two CTs are observed using an MR6000.

Fig.4 Photograph of test setup

IMPULSE WINDING TESTER	ST4030A	HIOKI
MEMORY HiCORDER	MR6000	HIOKI
CURRENT PROBE (CT1)	CT6711	HIOKI
HFCT Current Transformer Broad Frequency Response (CT2)	CT-B5.0	MAGNELAB
High-Voltage Differential Probe	TA044	Pico Technology

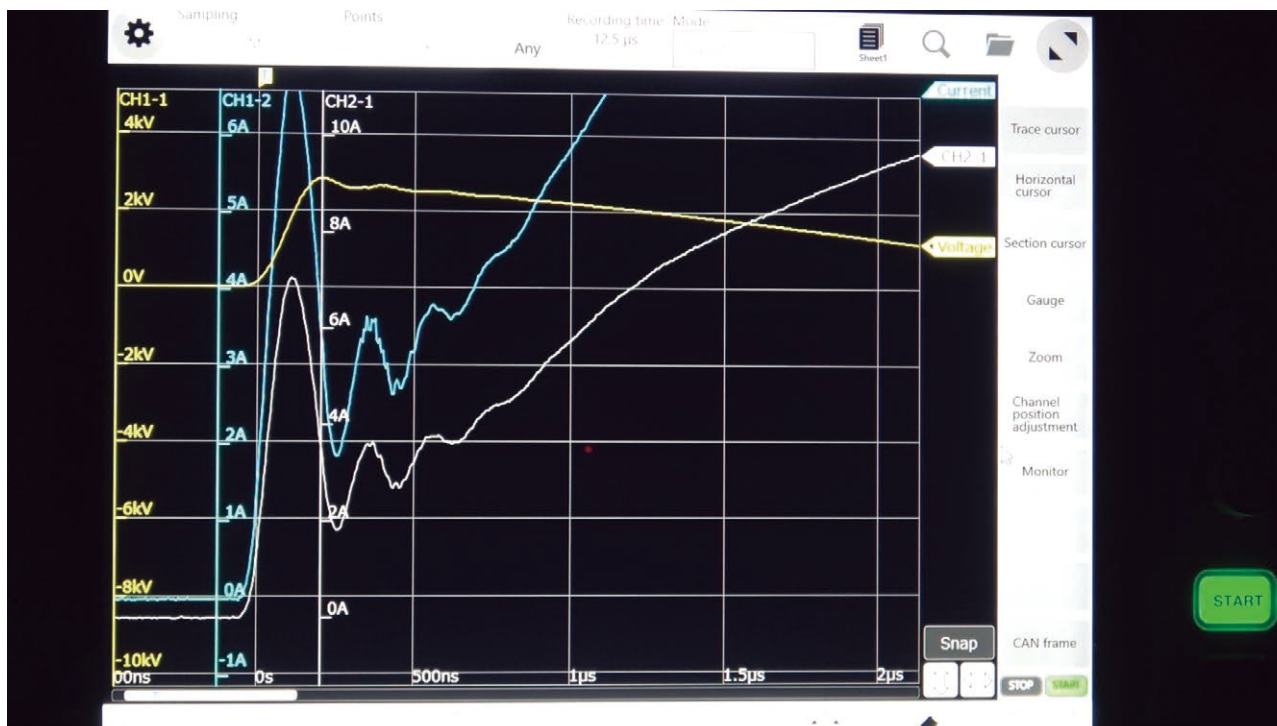
- The current waveforms did not exhibit significant disturbances at a test voltage of 2000 Vpeak.
- A significant disturbance resembling a pulsating current was observed at a test voltage of 2600 Vpeak. That disturbance indicates a partial discharge.

- Partial discharges can be detected by observing current waveforms during impulse testing.
- If there is a low level of insulation, the discharge starting voltage will decrease.
- It may be possible to automate testing using the oscilloscope's trigger or spectrum analyzer function.
- However, it will be necessary to exercise caution concerning grounding and the noise environment.
